Seismic Mitigation for Equipment at Army Medical Centers

Methods Illustrated With Examples from Madigan Army Medical Center

by
James Wilcoski

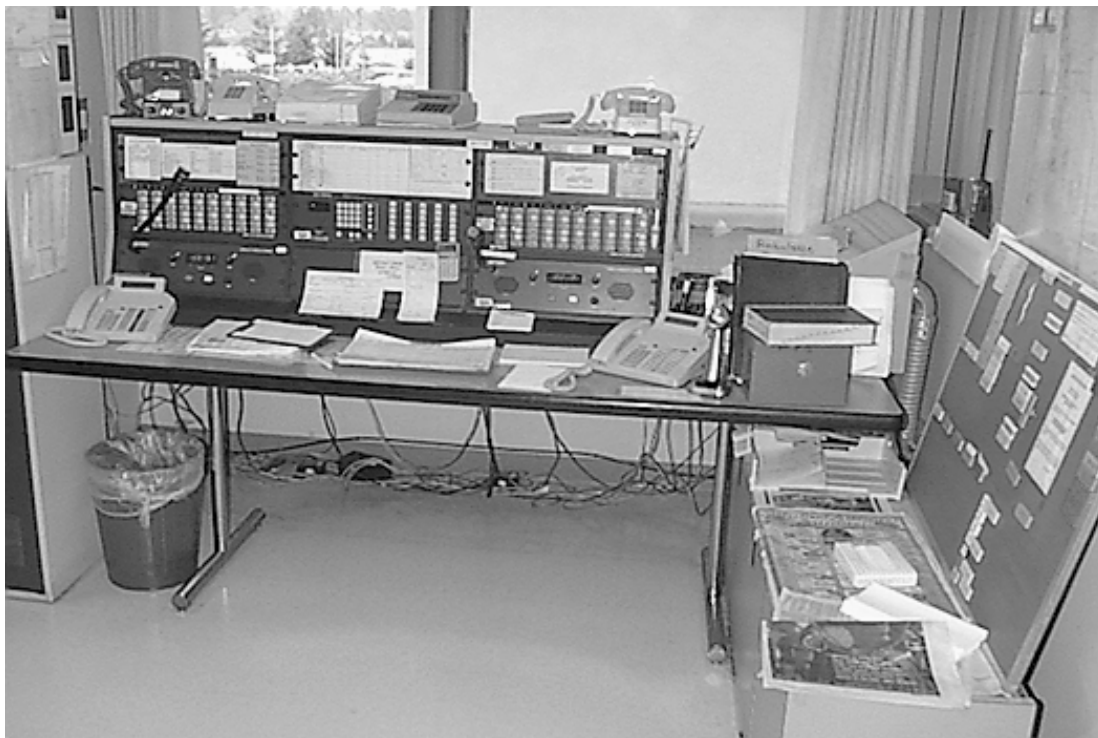
Figure 22 shows what may be the most urgent problem found at MAMC. Communications equipment at the emergency room communications center was resting loosely on a folding table, which in turn rests loosely on the floor. Figure 23 shows the edge of this equipment, which demonstrates how tall it is relative to its depth. According to the operators of this equipment, the supplier sent the wrong support cabinet. Apparently this unit was temporarily set loosely on the table, but the correct cabinet was never obtained or installed. In even a moderate earthquake the table would slide on the floor and the equipment would topple. The correct cabinet should be ordered as soon as possible. The communications equipment should be anchored to the cabinet and cabinet should be anchored to the floor. If this cannot be done immediately, the equipment should temporarily be anchored to a more stable counter. In this same room security monitors and fire detection units were well anchored, but the back of their cabinets were open. These cabinets should be closed to prevent the monitors from falling out backwards during an earthquake.

Figure 22. Equipment at emergency room communications center resting loosely on a table.

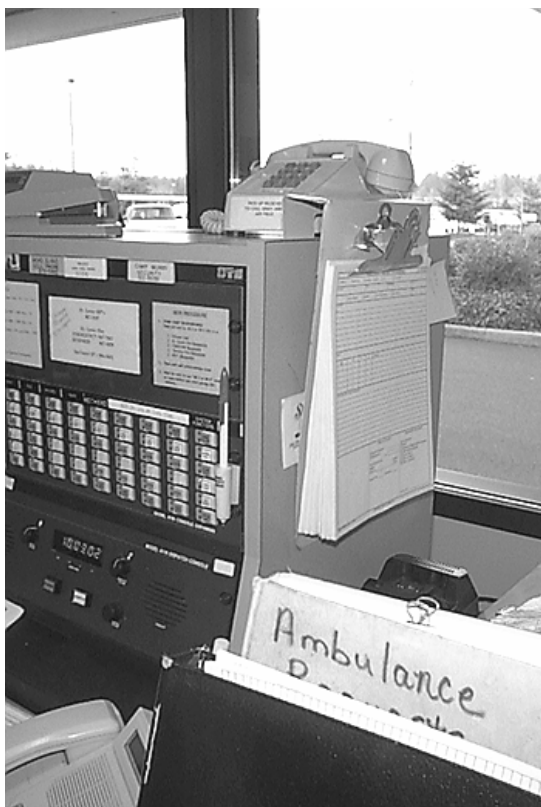
Figure 23. Side view of communications center equipment.

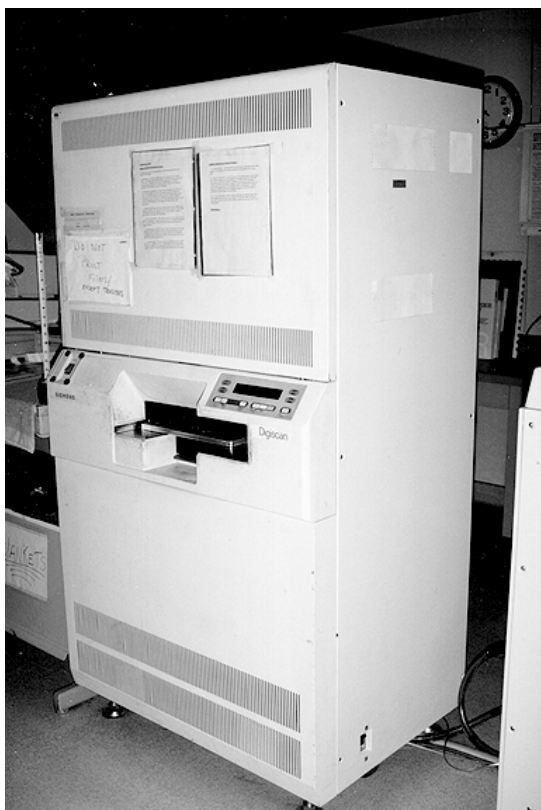
Figure 24 shows equipment that is part of the MDICC system. This particular equipment uses a laser to convert x-ray film plate images to digital records. Figure 25 is a close-up of a wheel and leg at one corner, showing that it is not anchored to the floor. The leg shown could easily be modified to anchor it to the floor.

Figure 24. Digiscan (Fuji 7000) supporting the Medical Digital Imaging Control Center system.

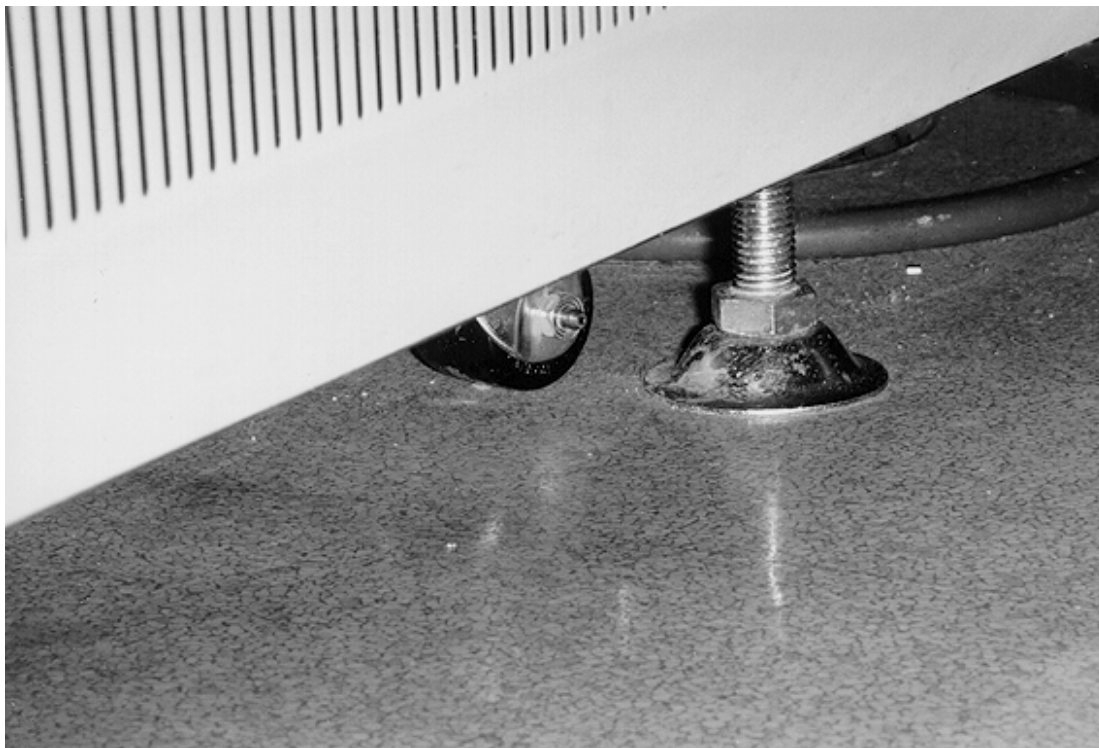
Figure 25. Close-up showing lack of anchorage for the Digiscan equipment.

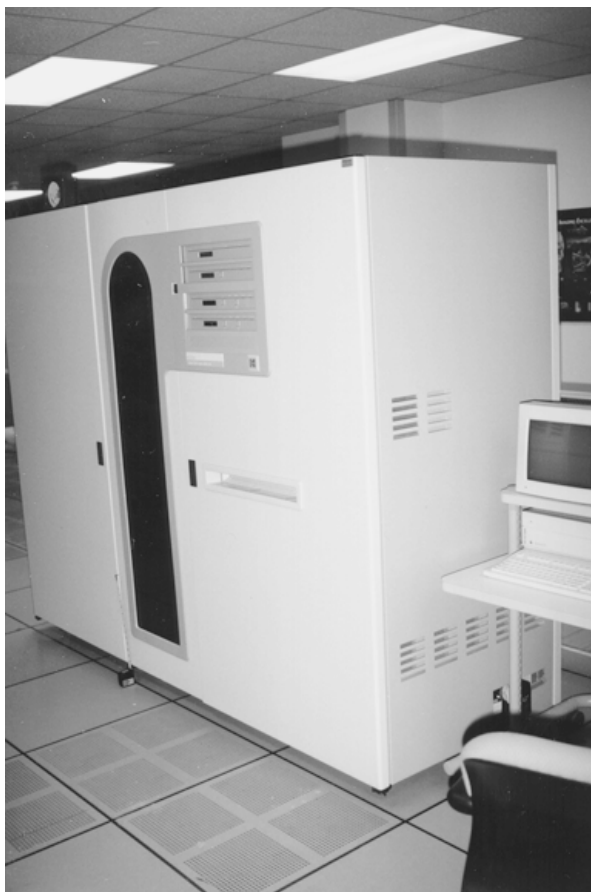
Figure 26 shows a Kodak Optical Disk System (6800-ADL). This unit stores and moves optical platters containing x-ray image data into read stations. This unit

Figure 26. Kodak Optical Disk System (6800-ADL).

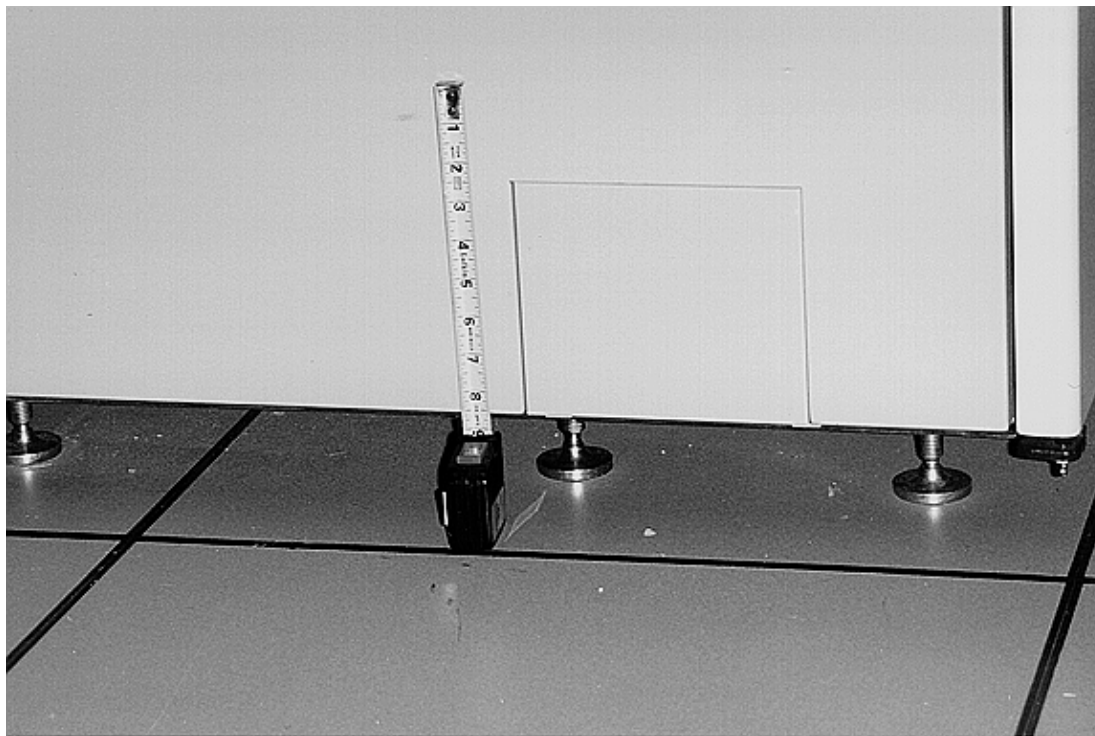
rests loosely on the computer floor (Figure 27) and is of critical importance to medical staff at MAMC. The supporting computer floor tiles are loosely supported on a stringer system frame. Computer floors supported on stringer system frames apparently perform well in earthquakes. Other computer floors are supported on a stringer-less system where a post supports and should be fastened to each corner of the floor tiles. These posts must be braced to resist lateral seismic motions. Often the fasteners are left out, and in earthquakes loose tiles near equipment could shift off their posts, and drop to the floor below. This in turn would allow equipment to shift and drop into the fallen tile area on one side, and then fall over. All critical equipment should either be bolted to the floor below the tile using a tie-rod or, for lighter equipment, bolted to individual floor tiles. Figure 28 shows a mainframe computer, supported on a computer floor that was tested on the USACERL Triaxial Earthquake and Shock Simulator (TESS). This was the standard field installation for seismic design where the tiles were fastened to the computer floor posts, the posts were braced, and the computer was fastened to the floor below using a tie-rod that penetrated the computer floor surface. This configuration performed well in seismic qualification tests.³

Figure 27. Close-up showing lack of anchorage for the optical disk system.

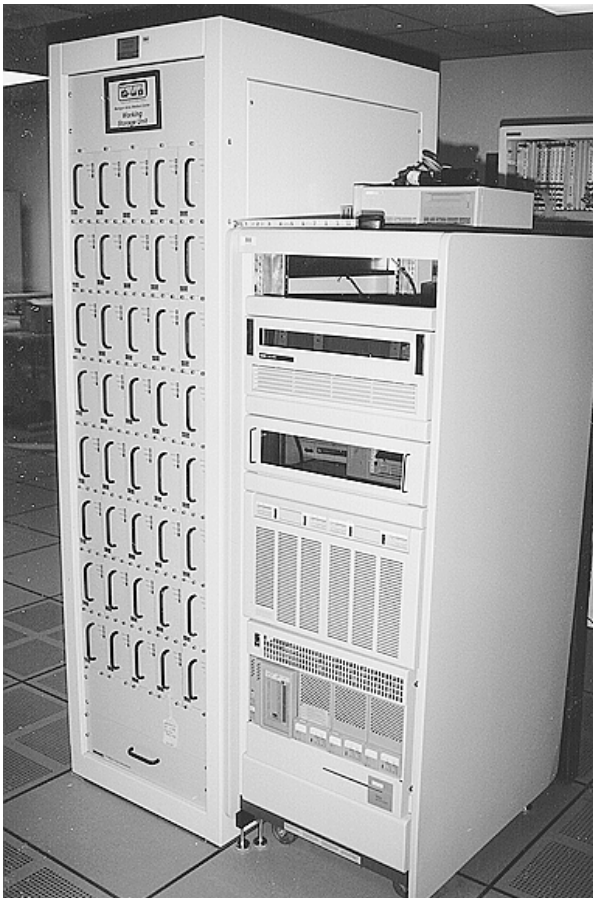
The right side of Figure 29 shows the mini-computer central processing unit (CPU), a Digital VAX 4000-505A. This critical computer supports the entire MDICC system but it is unanchored, as seen in Figure 30.

Figure 29. Digital-VAX mini-computer CPU supporting the MDICC.

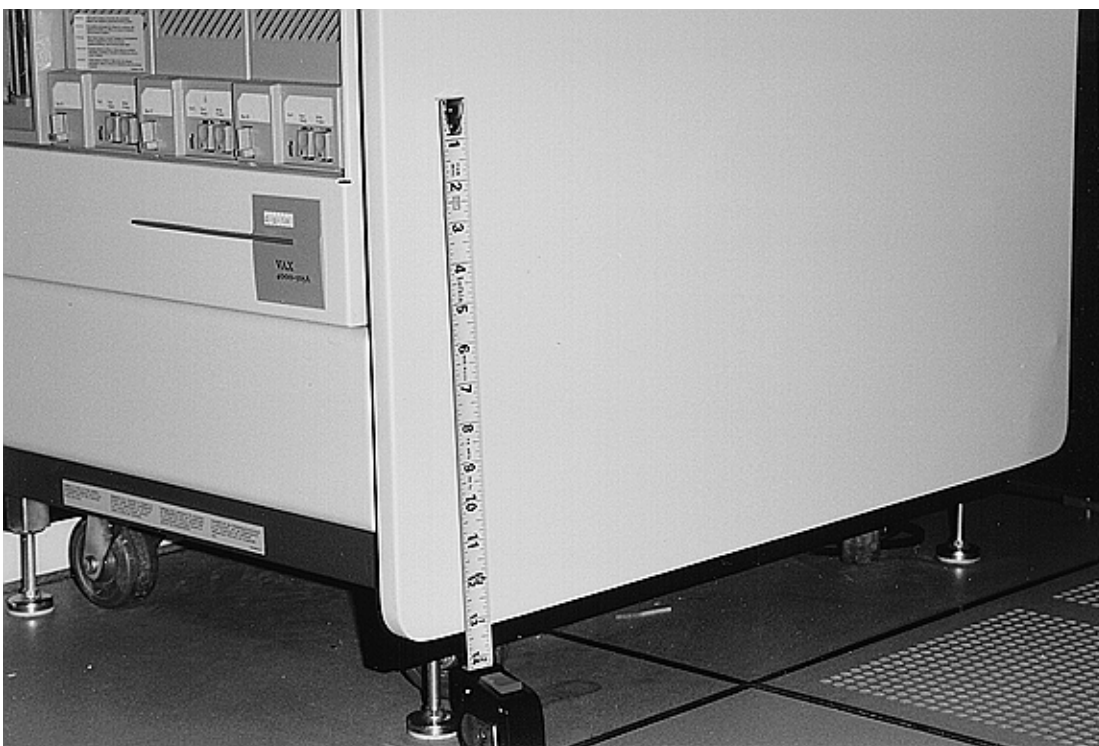
Figure 30. Close-up showing a lack of anchorage for the mini-computer.

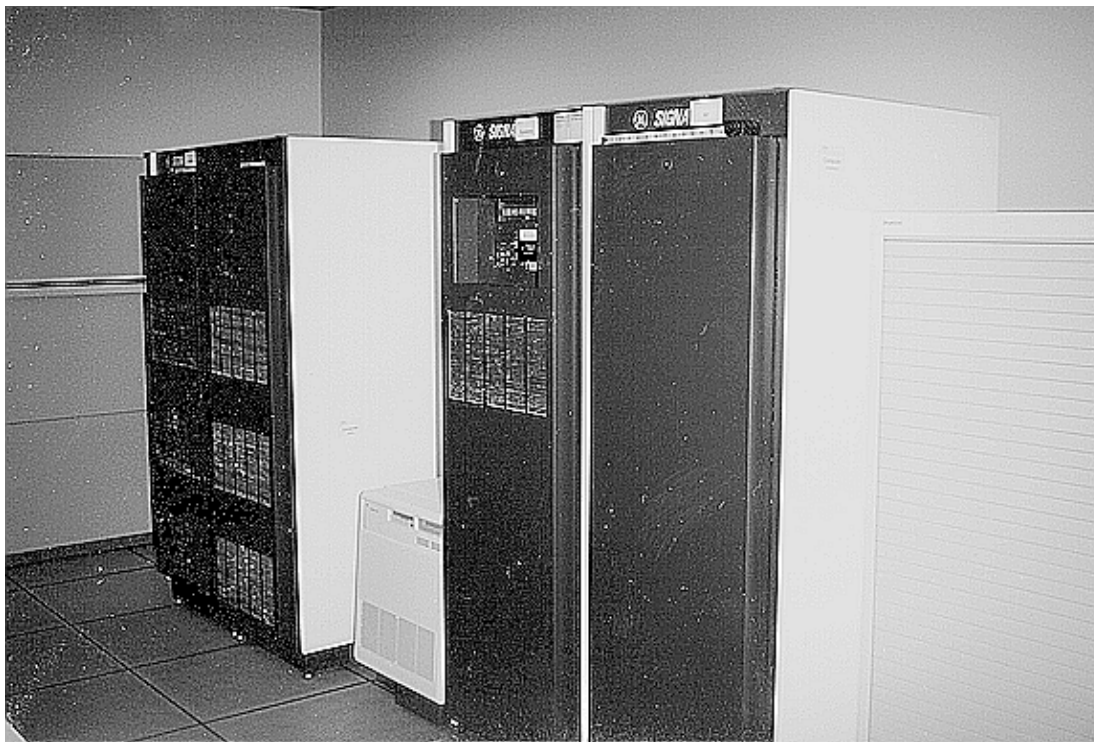
Figure 31 shows the computers (GE SIGNA) that control MAMC's MRI system. These computers are not anchored. The smaller computer shown in Figure 32, which records MRI results, is anchored to the computer floor rather than to the floor below. All of these machines are vulnerable for the reasons described above. The MRI equipment anchorage should be upgraded in the same manner described above for the MDICC system.

Figure 31. General Electric (GE) computers that control the MRI system.

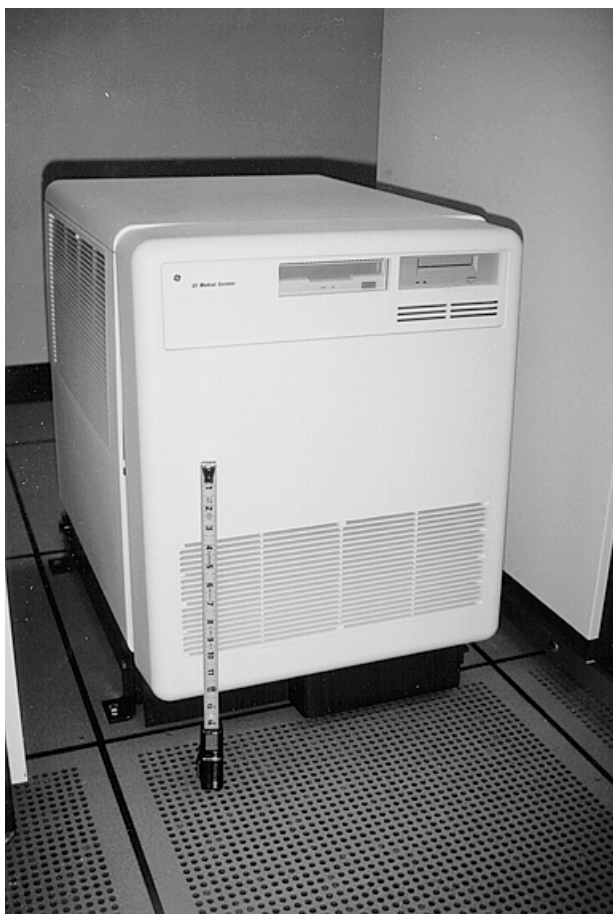
Figure 32. Computer that records MRI results, anchored to a single computer floor tile.

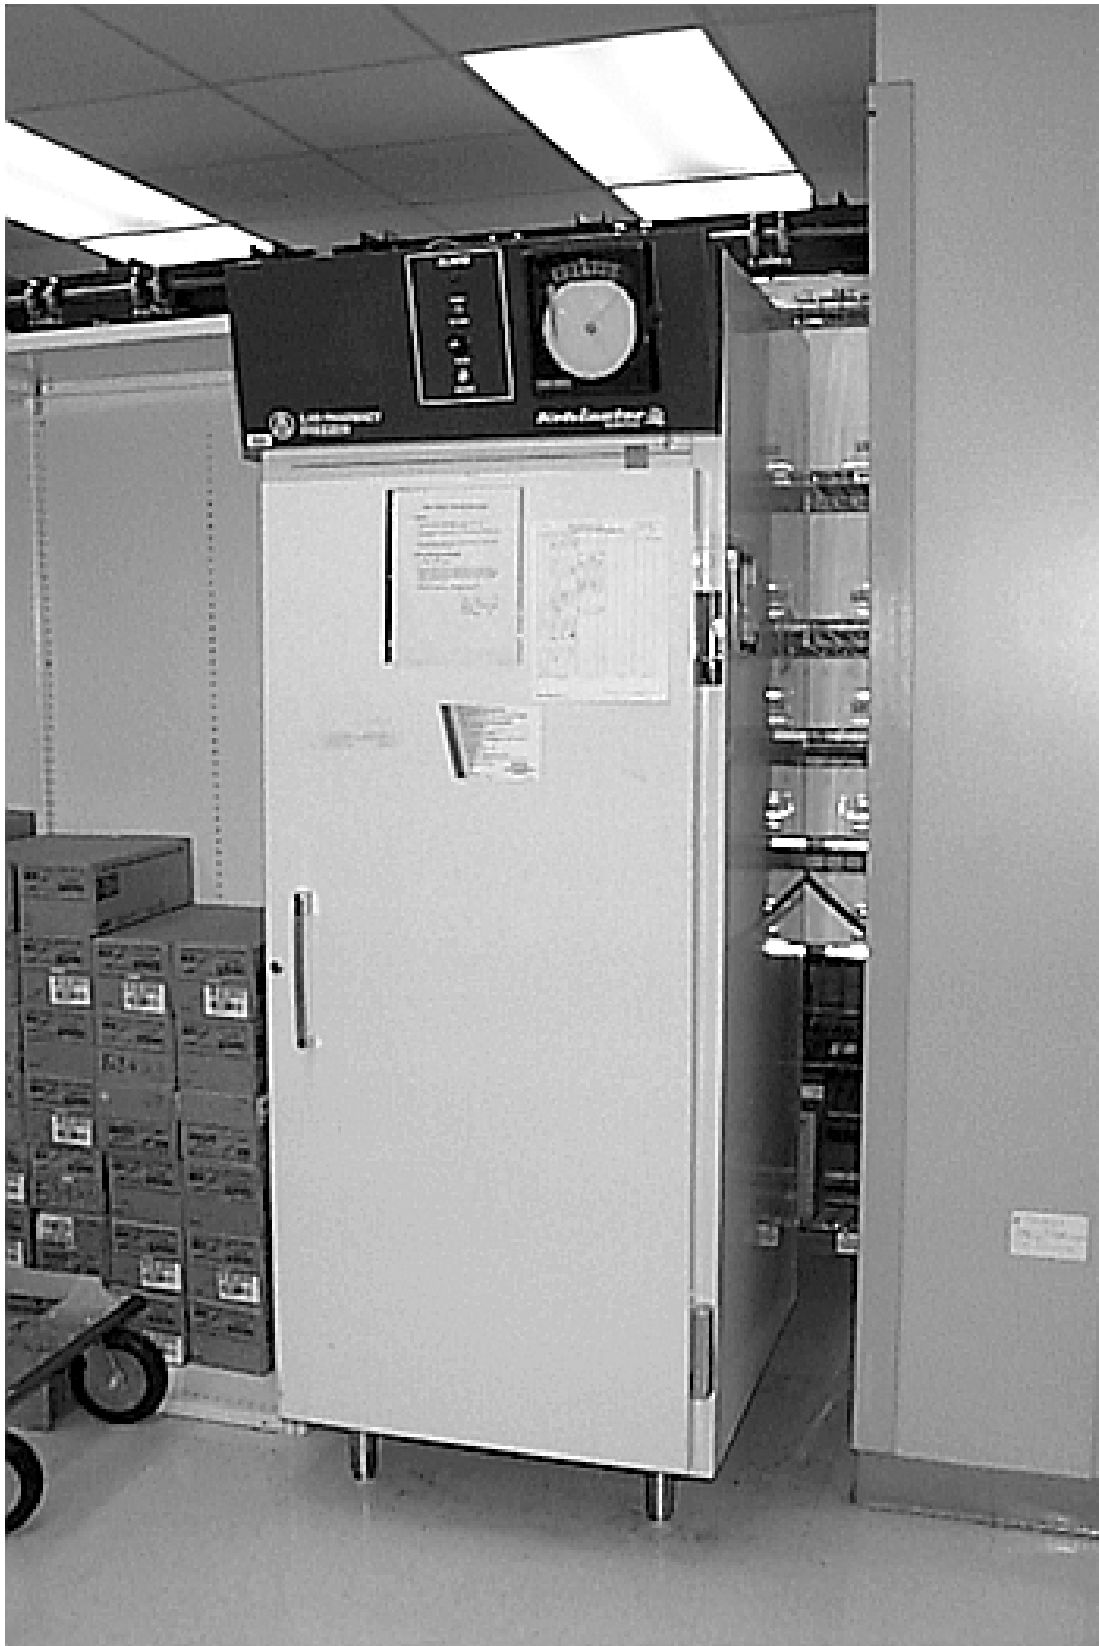
The outpatient pharmacy, which also serves the inpatient nursing tower, contains many tall narrow cabinets that are not anchored. Figure 33 shows a pharmacy freezer that is quite tall, has a small footprint, and is unanchored. (It should be noted that the kitchen also has many tall, narrow unanchored coolers and freezers similar to this.) These should either be braced (see Figures 4 and 14) or anchored to the floor. Figures 34 and 35 show tall, narrow shelves. These shelves can be simply braced by bolting them to a wall or to each other in a T or L configuration (in plan). The two shelves shown in Figure 34 could be braced by simply bolting them to each other near their tops and bottoms. (They will form a T configuration in plan if left in the positions shown in this figure.) Tall shelves such as those shown in Figures 34 and 35 could also be braced to the ceiling structural system. Shelves that are at least seven feet tall configured in parallel rows can be braced to each other perpendicular to the row and across the tops. Figure 36 shows small storage bins in the pharmacy. These bins have a small lip at the front. Storage bins like these should have a higher retainer edge to keep contents in the bins. The same retainer edge should be used for horizontal shelves throughout MAMC. It is recognized that such a retainer edge would make shelves slightly less accessible, but this is a relatively small cost to protect important medical assets. This approach is used in other types of facilities in active seismic regions, such as libraries in California which often have wires in front of books to hold them in place during an earthquake. Lightweight contents can also be held on shelves with cabinet doors with latches.

Figure 33. Tall unanchored pharmacy freezer with a narrow footprint.

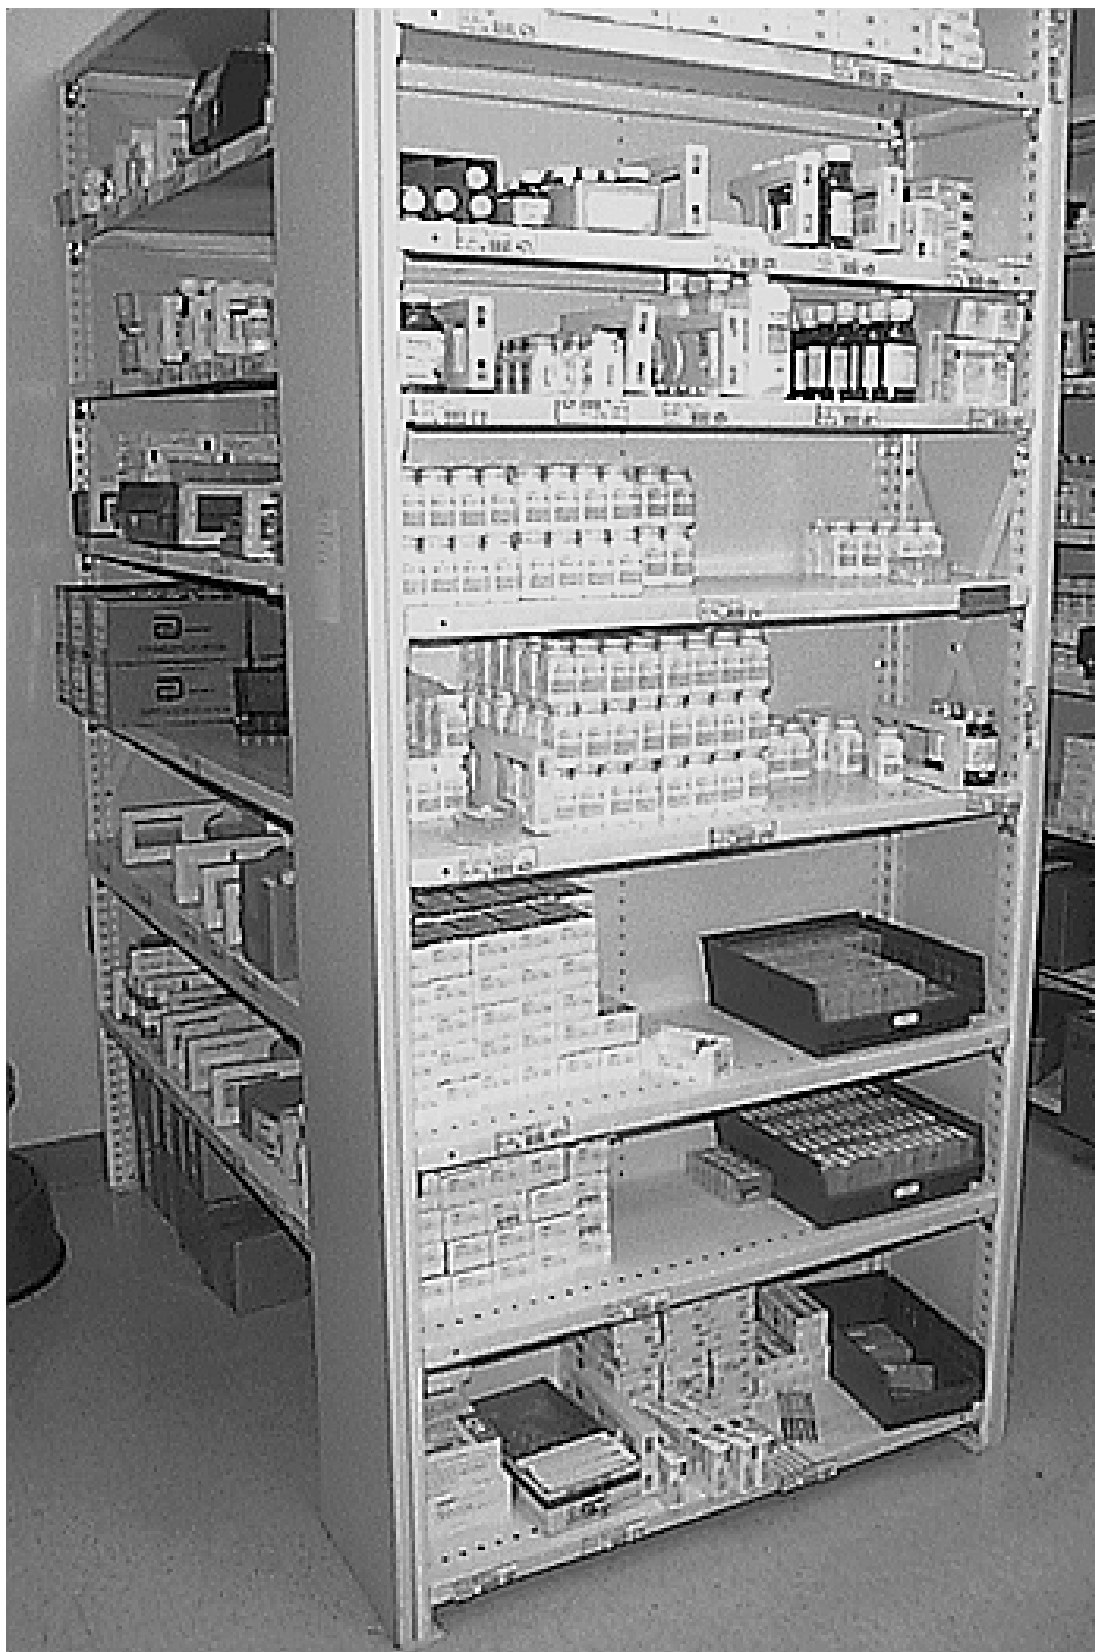
Figure 34. Unanchored tall narrow shelves that may be secured in their present configuration.

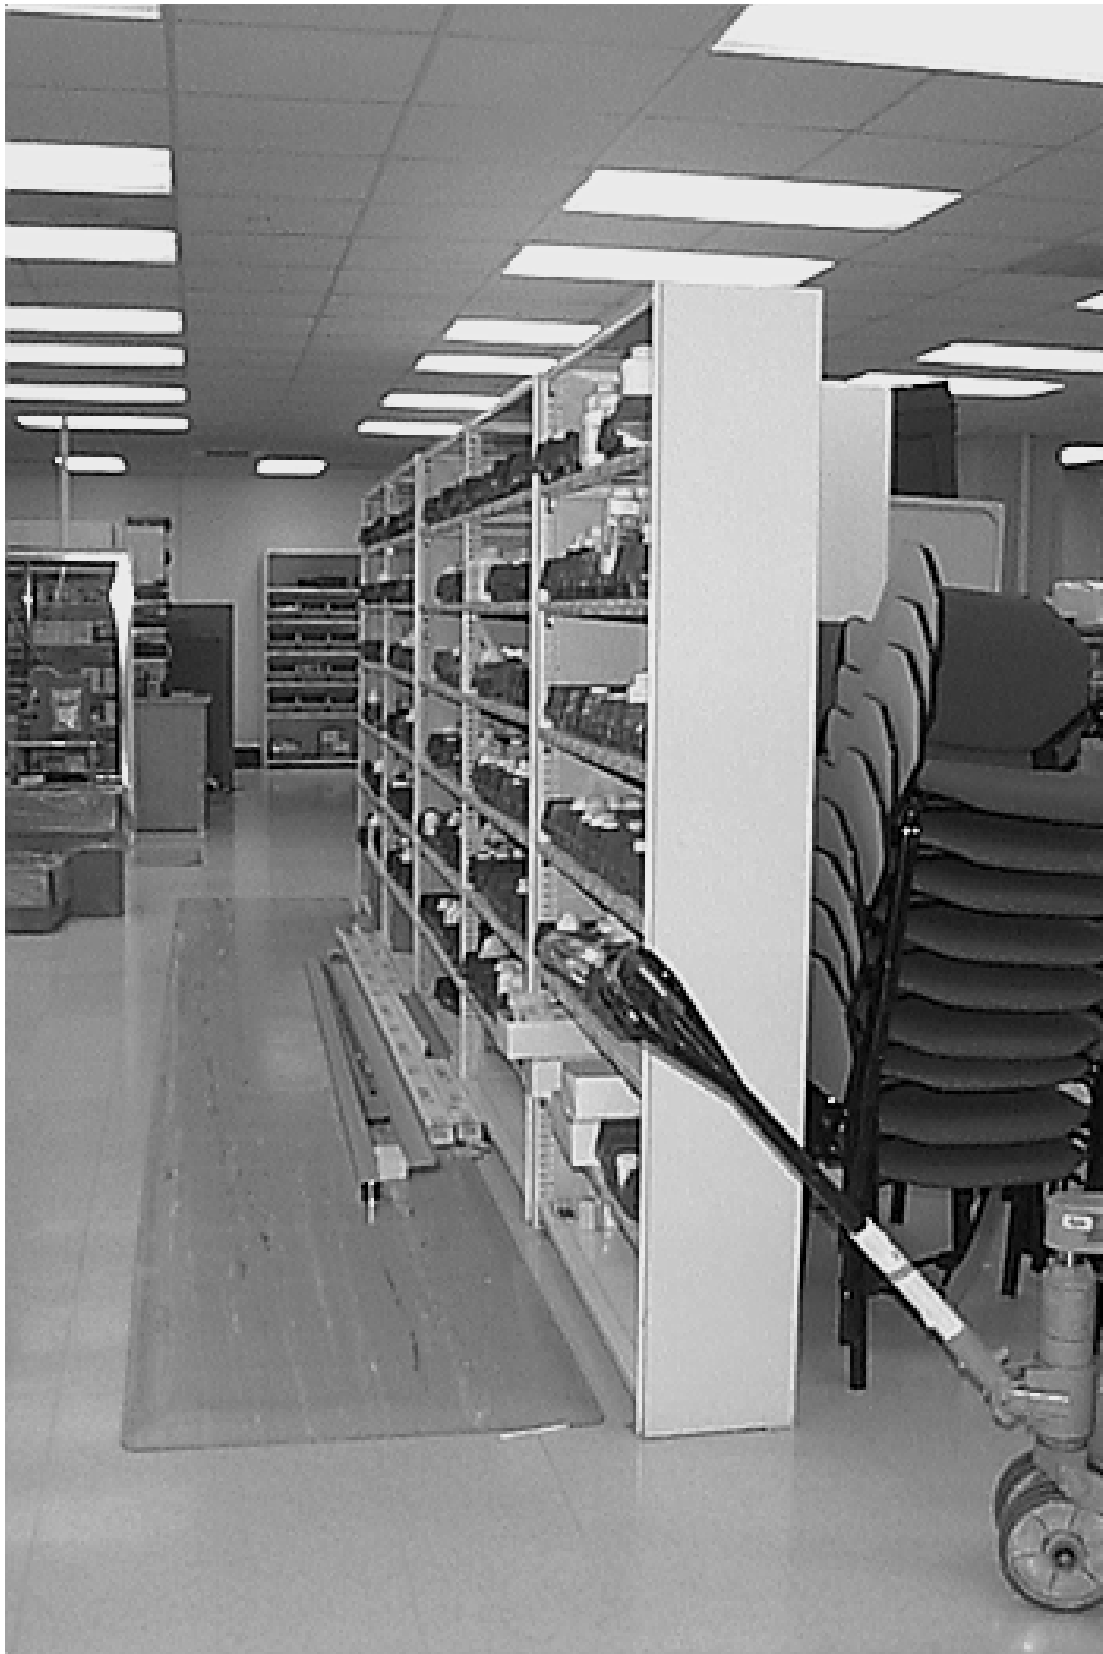
Figure 35. Unanchored tall narrow shelves.

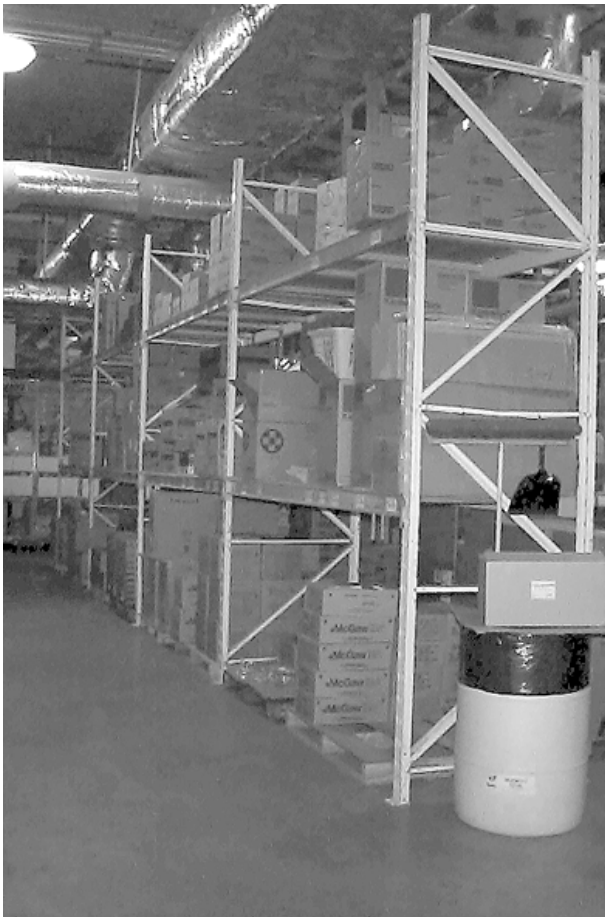
The logistics area provides shipping and receiving services plus some storage. Figure 37 shows tall narrow storage racks that are unanchored (Figure 38). The storage rack leg shown in Figure 38 has bolt holes for anchoring the unit to the floor. These should be fastened to the floor, or they may also be braced by bolting to each other, to a wall or to the ceiling structural system. If bolted to each other, they should be fastened near their tops and bottoms to form a T or L configuration, as described above for the pharmacy shelves. Shelf bracing must be designed so as to avoid long unsupported lengths of shelving. Figure 39 shows 55-gallon barrels stacked loosely. In an earthquake, these could easily topple and injure workers, damage property, or rupture. These barrels should remain stable if they are simply unstacked.

Figure 37. Tall, narrow storage racks in the logistics area.

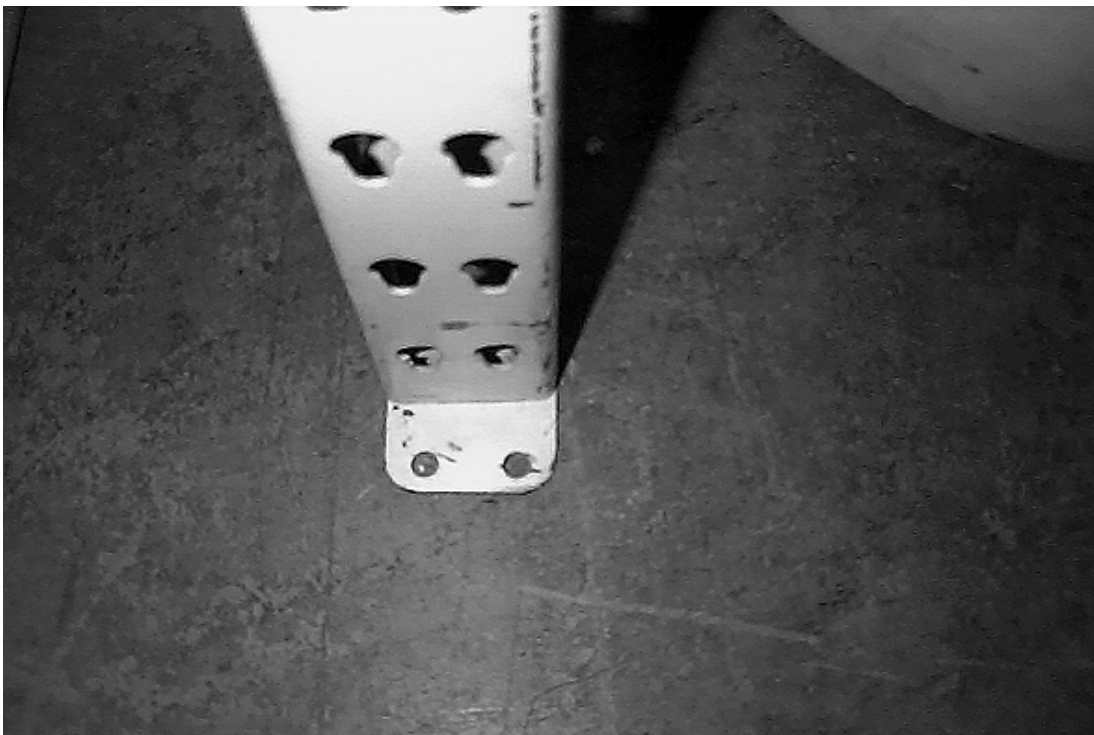
Figure 38. Close-up of logistics area storage racks showing lack of anchorage.

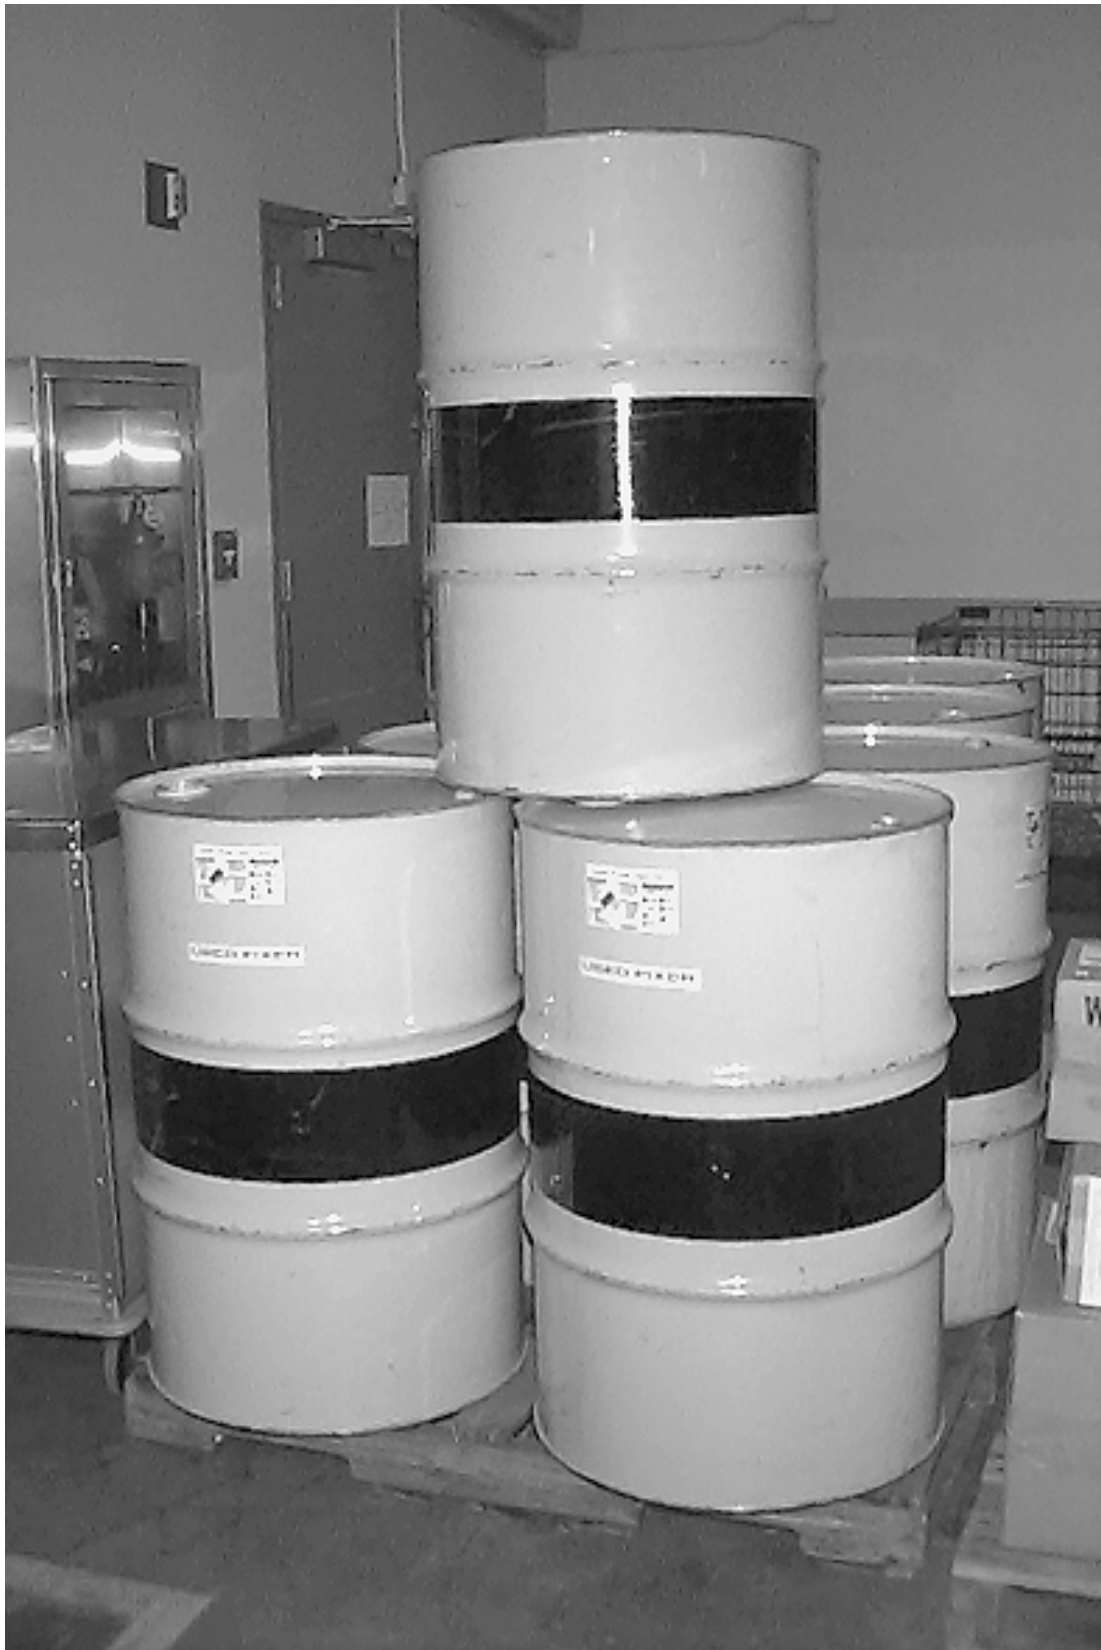
Figure 39. Loosely stacked barrels.

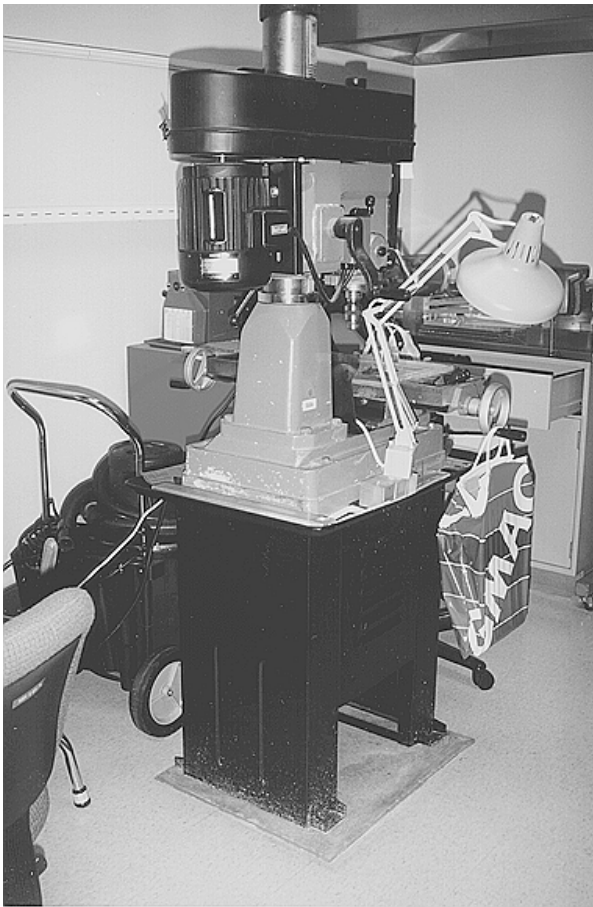
Figure 40 shows an unanchored milling machine that is fairly tall and has a narrow footprint. The bolt holes shown in Figure 41 demonstrate that this machine can easily be bolted to the floor. Figure 42 is a low-melting alloy dispenser, providing molten lead for casting radiation shielding blocks. This unit weighs over 100 lb (45 kg), and is resting loosely on the countertop. It should be anchored to the countertop or braced back to the wall. Figure 43 shows typical laboratory equipment — both the cabinet and its contents should be anchored. Also note the file cabinet on the right side of this figure — it is unanchored and may easily topple, blocking escape from the door next to it.

Figure 40. Tall, narrow milling machine.

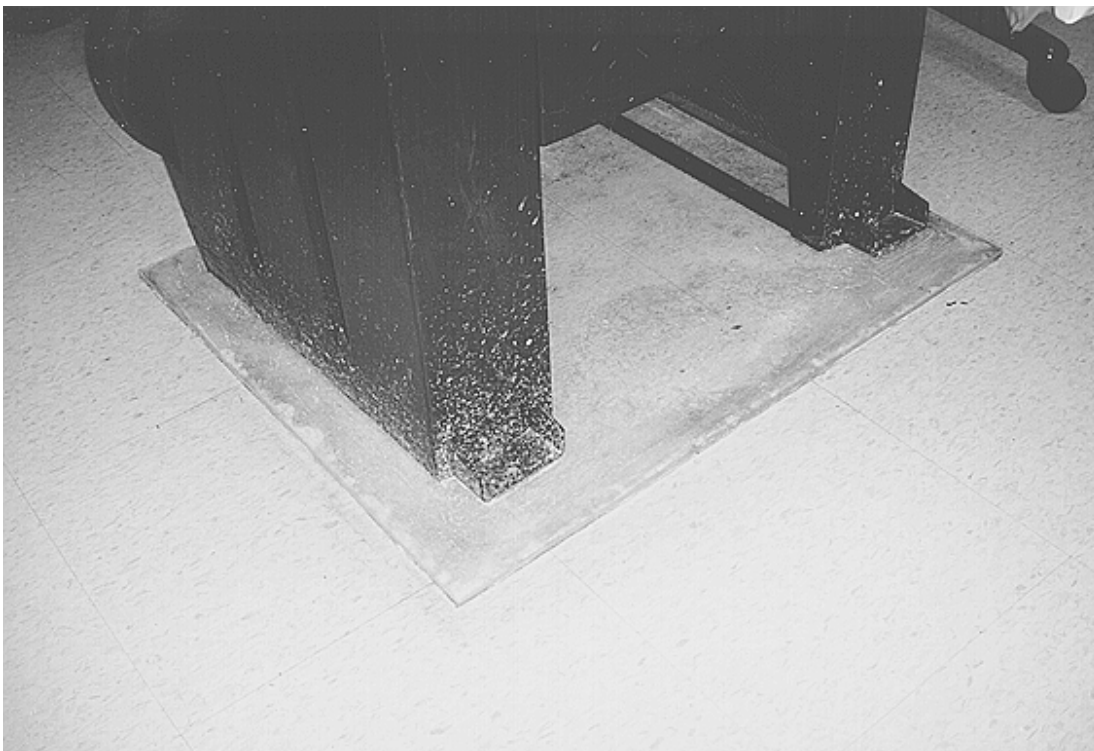
Figure 41. Close-up of milling machine legs showing bolt holes for anchorage.

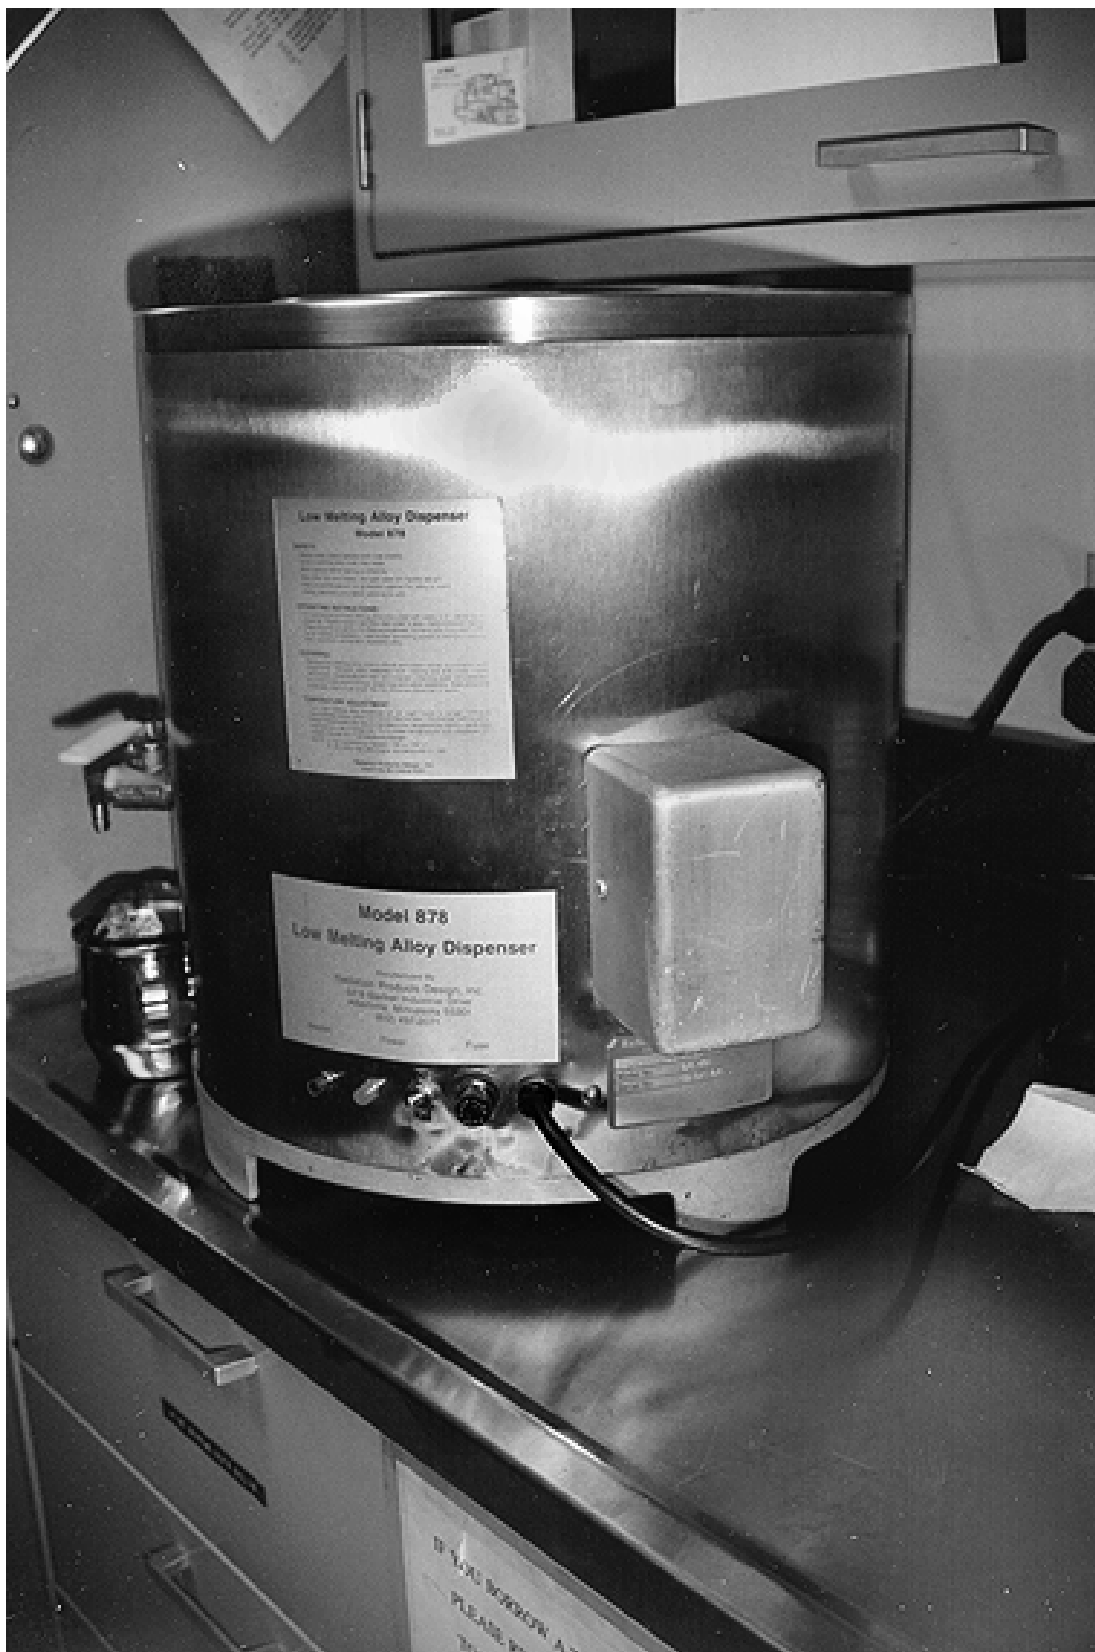
Figure 42. Low-melting alloy dispenser, shown resting loosely on countertop.

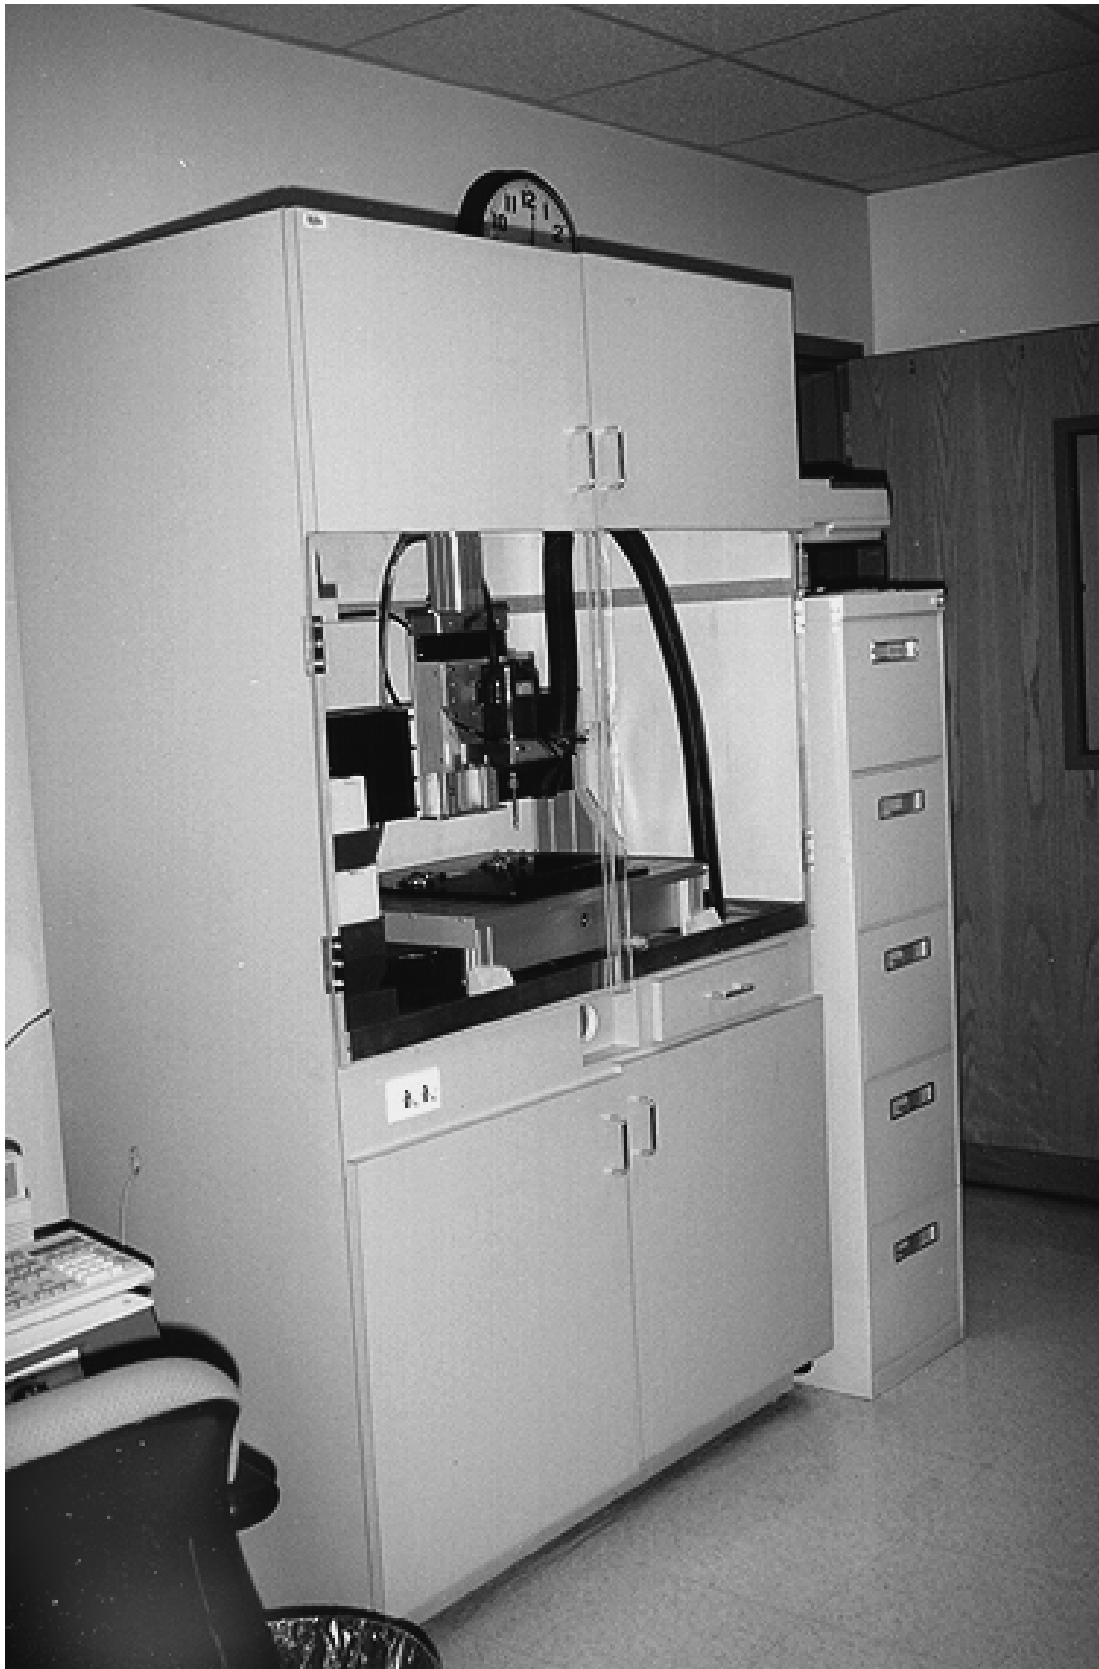
Figure 43. Unanchored typical laboratory equipment.
